## Case 361 : Narrative

Case Vehicle (A): 1999 Jeep
Type: Cherokee, 4-door SUV, 4x4
Driver: 23-year-old male
CDC: 12-FLEE-5

CASE NO.: 361-03

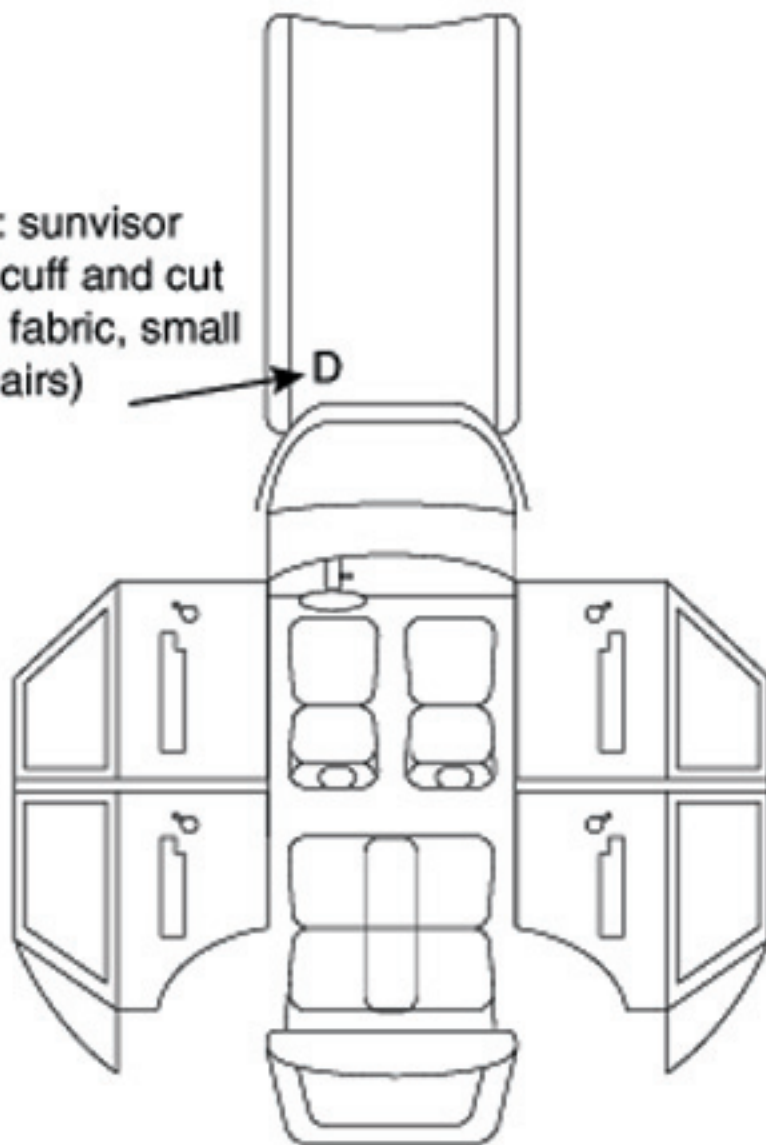
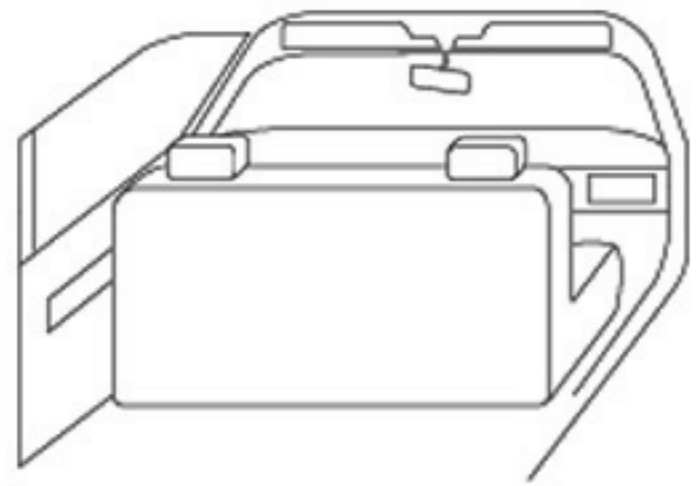
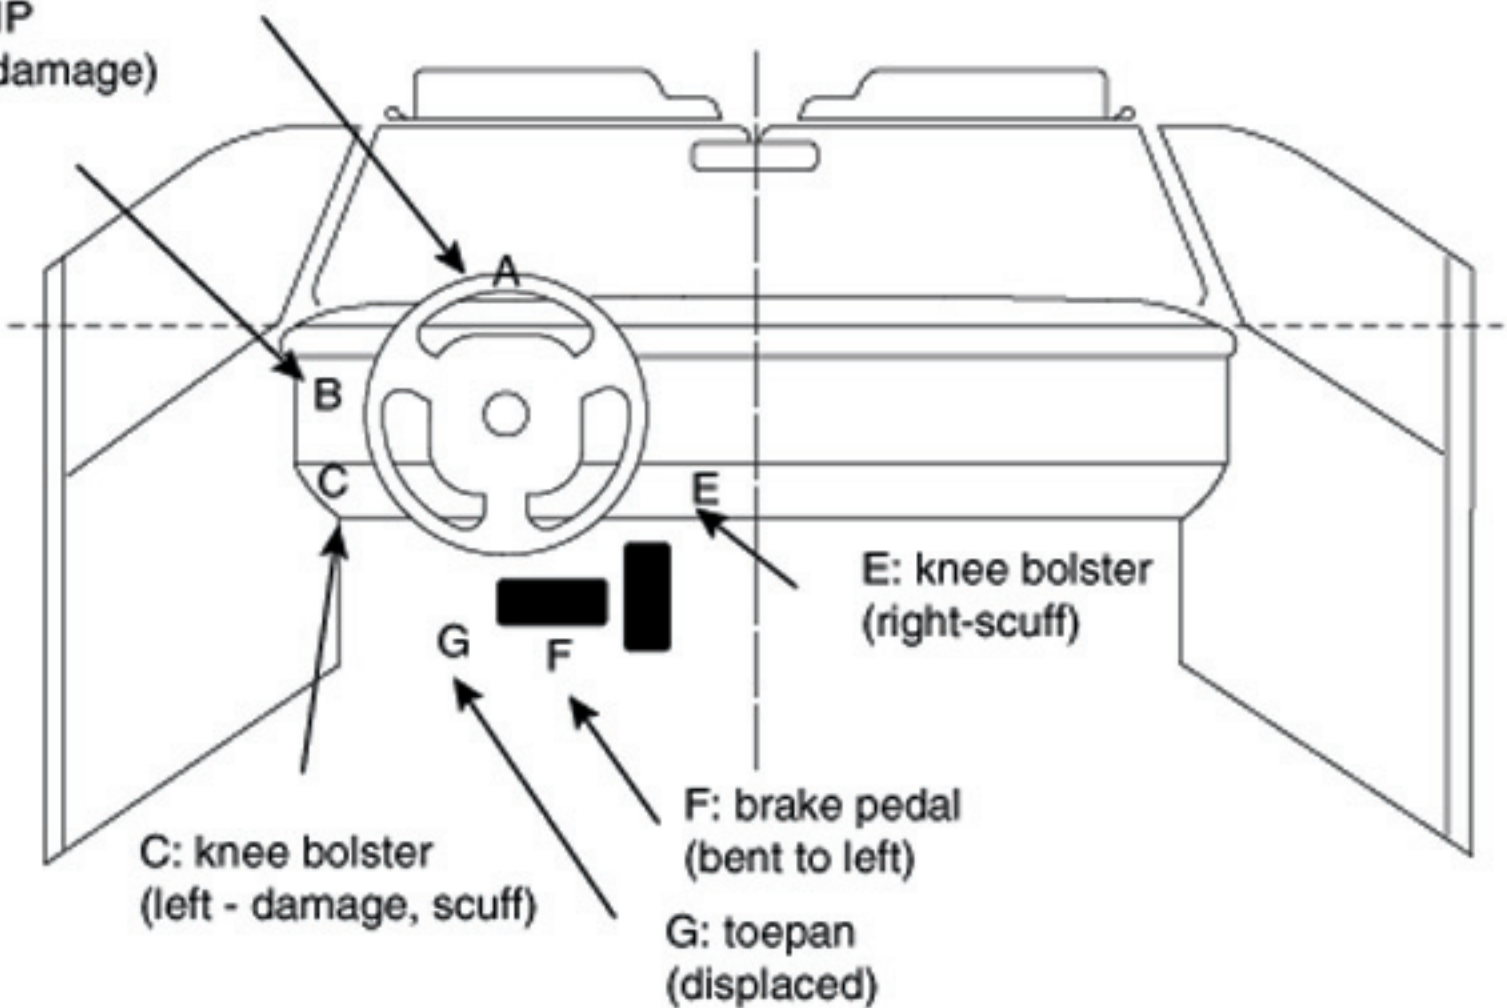
D: sunvisor  
(scuff and cut  
in fabric, small  
hairs)

no evidence of driver belt use

steering-wheel pointed at 6:00 pm  
at vehicle inspection

A: steering-wheel rim  
(upper half has 10-cm forward deflection)

B: mid IP  
(scuff, damage)
